DEPARTMENT OF TRANSPORTATION**DIVISION OF ENGINEERING SERVICES**

Quality Assurance and Source Inspection

Contract #: 04-0120F4Cty: SF/ALA Rte: 80 PM: 13.2/13.9File #: 69.28**WELDING INSPECTION REPORT****Resident Engineer:**Pursell, Gary**Address:** 333 Burma Road**City:** Oakland, CA 94607**Report No:** WIR-012405**Date Inspected:** 27-Feb-2010**Project Name:** SAS Superstructure**OSM Arrival Time:** 1900**Prime Contractor:** American Bridge/Fluor Enterprises, a JV**OSM Departure Time:** 700**Contractor:** Zhenhua Port Machinery Company, Ltd (ZPMC), Changxing Island **Location:** Shanghai, China**CWI Name:** See Below**CWI Present:** Yes No**Inspected CWI report:** Yes No N/A**Rod Oven in Use:** Yes No N/A**Electrode to specification:** Yes No N/A**Weld Procedures Followed:** Yes No N/A**Qualified Welders:** Yes No N/A**Verified Joint Fit-up:** Yes No N/A**Approved Drawings:** Yes No N/A**Approved WPS:** Yes No N/A**Delayed / Cancelled:** Yes No N/A**Bridge No:** 34-0006**Component:** OBG**Summary of Items Observed:**

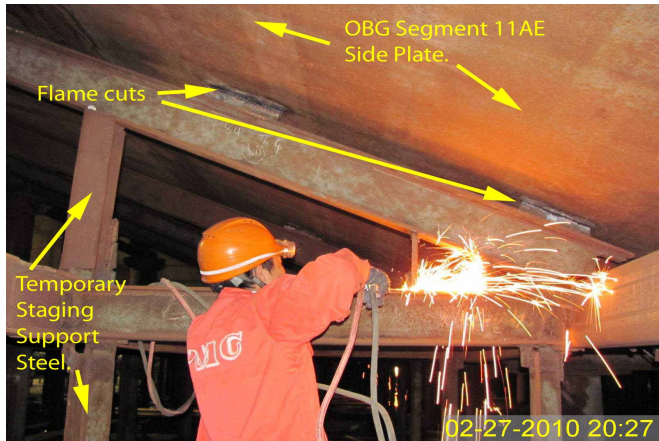
OBG Bays 13 and 14

This QA Inspector observed no ZPMC personnel were welding on Caltrans OBG segments. Several workers were using torches to flame cut temporary staging support steel members which had previously supported OBG segment 11E side plates. See the photograph below for additional information.
